Wire fractures in locked coil cables

Wire fractures in the main cables of the Lysefjord Suspension Bridge display an approximate linear relationship with time. Uncertainties related to wire fractures in sub-layers, reduction of load-carrying capacity and lifetime, and future development of wire fractures have prompted extensive investigations of the main cables. Failure analyses of fractured Z-wire samples and fracture mechanics analysis concluded that cracks have initiated and propagated from surface imperfections. The potential for hydrogen atom generation and absorption that causes hydrogen-induced cracking is discussed. Hydrogen atoms result from the hot-dip galvanization process, or due to corrosion. Evaluation of remaining load-carrying capacity and the need for strengthening of the main cables are briefly discussed and methods for surveillance of wire fractures are presented.

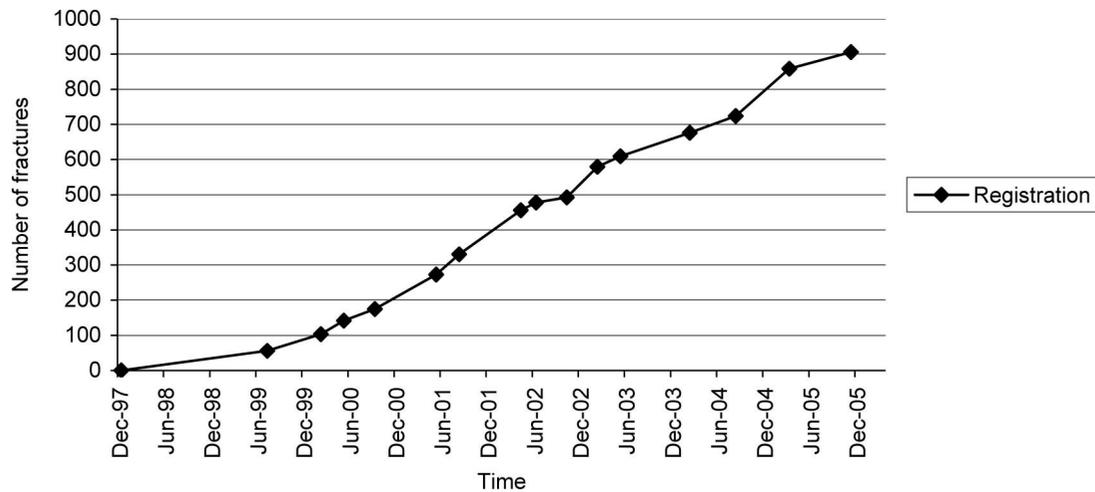
performed at least twice a year. Figure 3 shows the total number of wire fractures based on visual observations.

The fractures are evenly distributed along the length of the cables, and there is no indication of accumulation of fractures at saddle points or suspender clamps. Around the circumference of the cable cross-section there is a tendency to slightly more registrations of fractures on the top side than elsewhere.

Figure 3. Time development of wire fractures (accumulated).

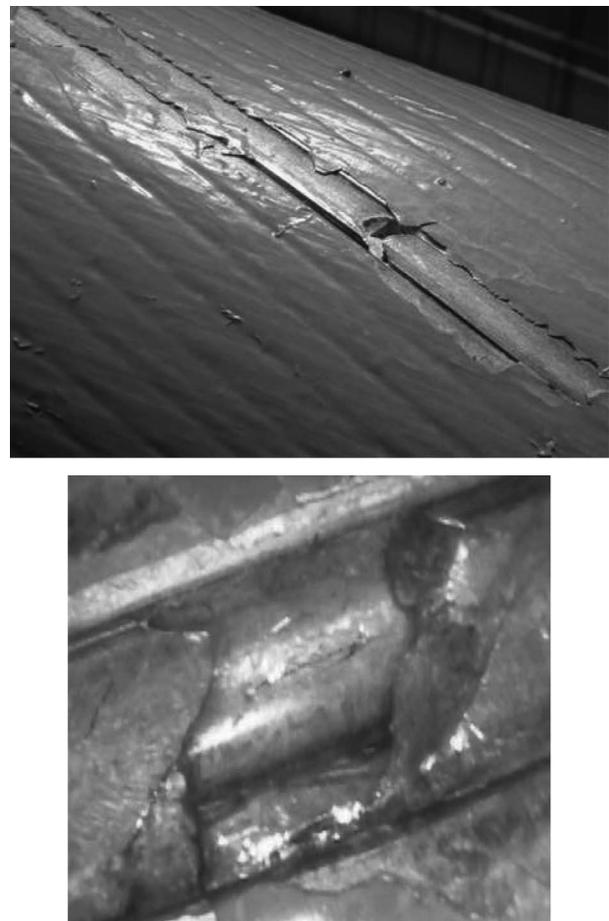
Figure 4. Photographs of fractured wire in cable at site.

As long as the wires are covered by the zinc layer, corrosion of the carbon steel substrate material will be prevented by the less noble zinc. If greater areas of the zinc coating is 'missing' leading to exposure of the substrate carbon steel material – by poor process control during galvanizing or by mechanical damage during fabrication – corrosion will occur on carbon steel. If corrosion of carbon steel occurs for a long period, the load-carrying area of the actual wire will be reduced and at a certain point the wire will break due to overload. This type of corrosion has been reported in the literature (Cao *et al.* 2002). However, pictures of broken wires shows that this reason can be excluded for the wire failures on the Lysefjord Suspension Bridge – see figure 4 showing examples of two broken wires.

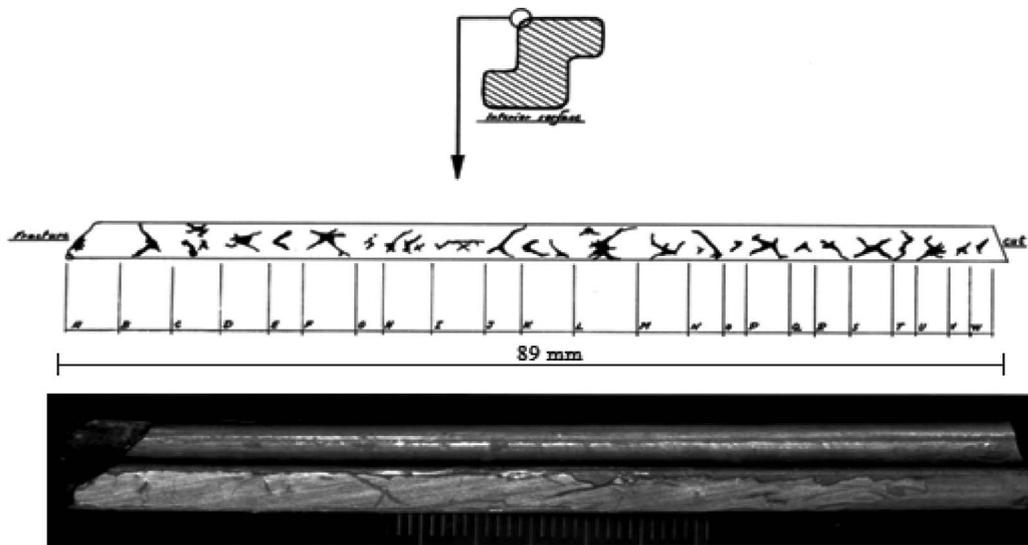
All of the examined samples showed surface irregularities which were located at the same profile edge as the fracture initiation areas. An examination of an uncleaned fracture surface disclosed the presence of dark-coloured areas observed in the vicinity of the initiation area of the fracture. These areas were examined more closely using a SEM.

Figure 5. Overview of typical wire sample taken from the outer layer of one of the main cables. The arrow points to the fracture surface. The sketch illustrates numerous surface defects found along the exterior surface edge after removal of paint and zinc layer (from Strengelsrud *et al.* 1999, with permission).

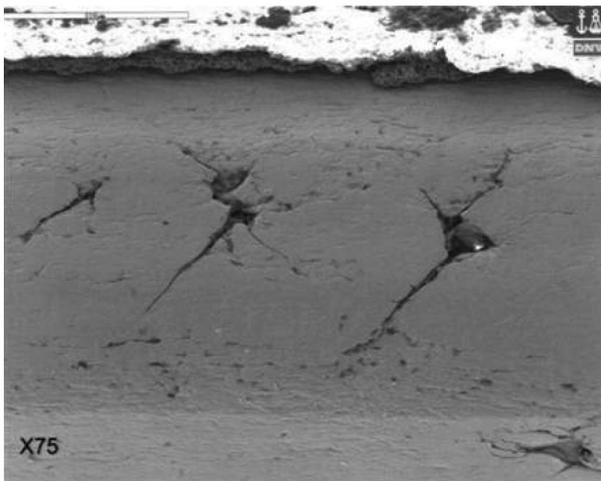
Figure 6. SEM photograph of some of the surface defects illustrated in figure 5. The zinc layer is removed.

imperfections were present: (1) cross-like geometry/shape resulting in lack of small pieces of surface material (see figure 6); and (2) surface imperfection most likely caused by some kind of surface material overlap during the geometrical forming (drawing/rolling) of the wire.

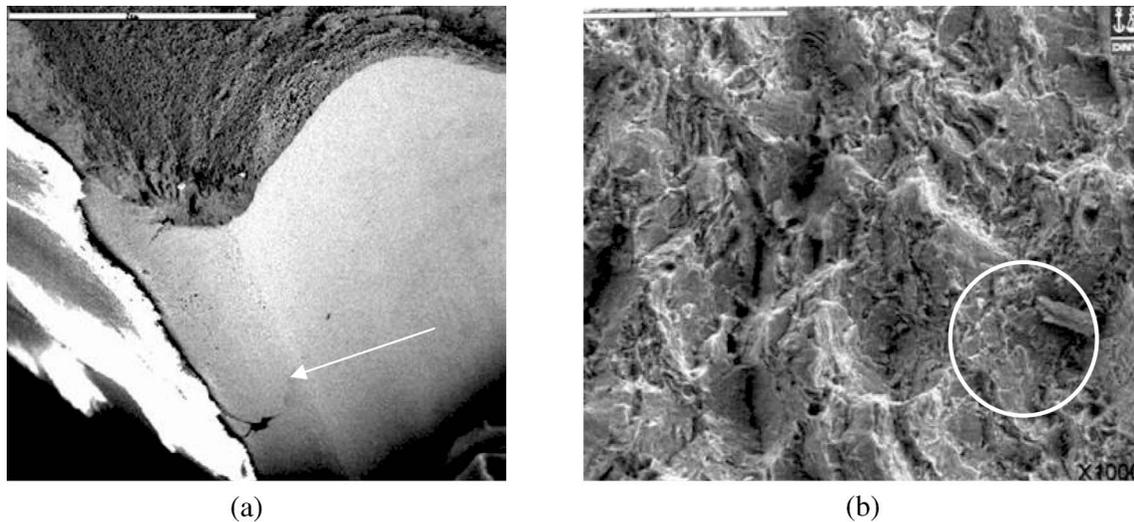
The majority of the imperfections were located at one profile ridge of the wire samples, the same ridge where the initiation areas were located. Figure 7b shows the general fracture mode being ductile with areas of brittle behaviour (cleavage) in between.

Figure 7. (a) The fracture surface pointed out in figure 5 and a surface defect in the adjacent area. SEM photograph, 25 \times . (b) A ductile fracture mode with areas of brittle behaviour as marked out. SEM photograph, 1000 \times .

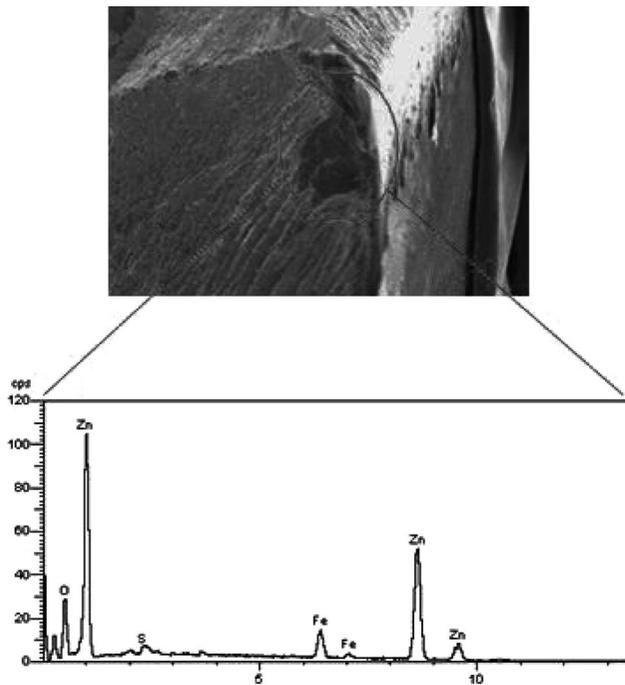
carried out for one wire sample. The analysis diagram representative for the initiation area (see figure 8) strongly indicates the presence of zinc (Zn) at the fracture surface. Since no zinc was detected in the central part of the wire, this observation confirms that the surface imperfection was present in the steel wire when the wire was subjected to hot-dip galvanization.

Figure 8. A qualitative element analysis diagram representative for the initiation area of the fracture (Leinum 2000).

The SEM and EDS analyses carried out on the fracture surface for one of the wire samples that had not previously been cleaned in acid showed that zinc was present at the fracture surface. The zinc was detected in the vicinity of the initiation area of the fracture and close to the surface of the wire. This confirms that the surface imperfections have been introduced prior to the galvanizing of the wires. Thus, it is likely that the observed imperfections have been created during the manufacturing, i.e. the rolling process. The surface appearance of the imperfections and the metallographic geometry also give the impression that the imperfections are a result of cold-flow overlap and/or local surface tearing during the plastic forming process of the wire.

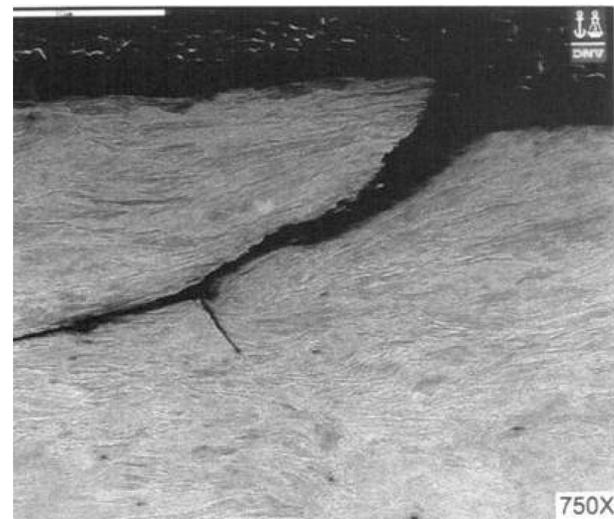
Figure 9 shows the defect in etched condition. As expected, the microstructure is heavily deformed as a result of the manufacturing process. Distinct flow lines can be seen in the vicinity of the defect, indicating that the defect has been introduced during manufacturing of the Z-wire.

Figure 9. Cross-section of typical surface defect (750 \times) (from Strengelesrud 1999, with permission).

The wire fractures in question have most likely initiated in connection with imperfections that probably are similar to those observed along the edge profile of the wires. The statement is further verified with the aid of a cross-section through one of the observed imperfections, which clearly show that a crack has initiated and propagated from the bottom of the defect. Thus the Z-wires have probably suffered a tensile overload fracture after a reduction in the cross-section of the wire related to the presence of imperfections and further crack propagation from the defects.

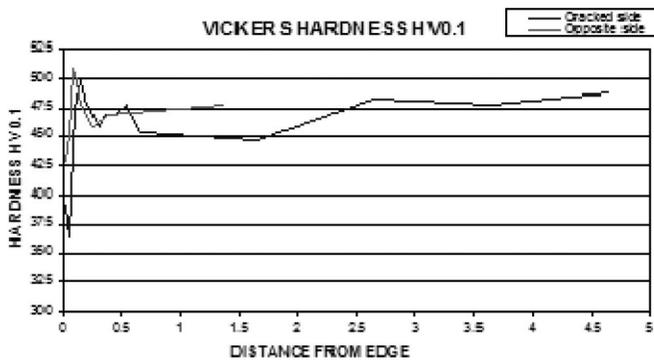
opposite wire surface. The results are graphically illustrated in figure 10, and show a hardness increase in the area close to the wire surface. This can probably be related to an increase in deformation in combination with a somewhat higher temperature caused by friction during the rolling process. The decrease in hardness just beneath the wire surface is connected to uncertainties in the performance of the measurements.

Figure 10. Hardness measurement (Leinum 2000).
