Wire fractures in locked coil cables

Wire fractures in the main cables of the Lysefjord Suspension Bridge display an approximate linear relationship with time. Uncertainties related to wire fractures in sub-layers, reduction of load-carrying capacity and lifetime, and future development of wire fractures have prompted extensive investigations of the main cables. Failure analyses of fractured Z-wire samples and fracture mechanics analysis concluded that cracks have initiated and propagated from surface imperfections. The potential for hydrogen atom generation and absorption that causes hydrogen-induced cracking is discussed. Hydrogen atoms result from the hot-dip galvanization process, or due to corrosion. Evaluation of remaining load-carrying capacity and the need for strengthening of the main cables are briefly discussed and methods for surveillance of wire fractures are presented.

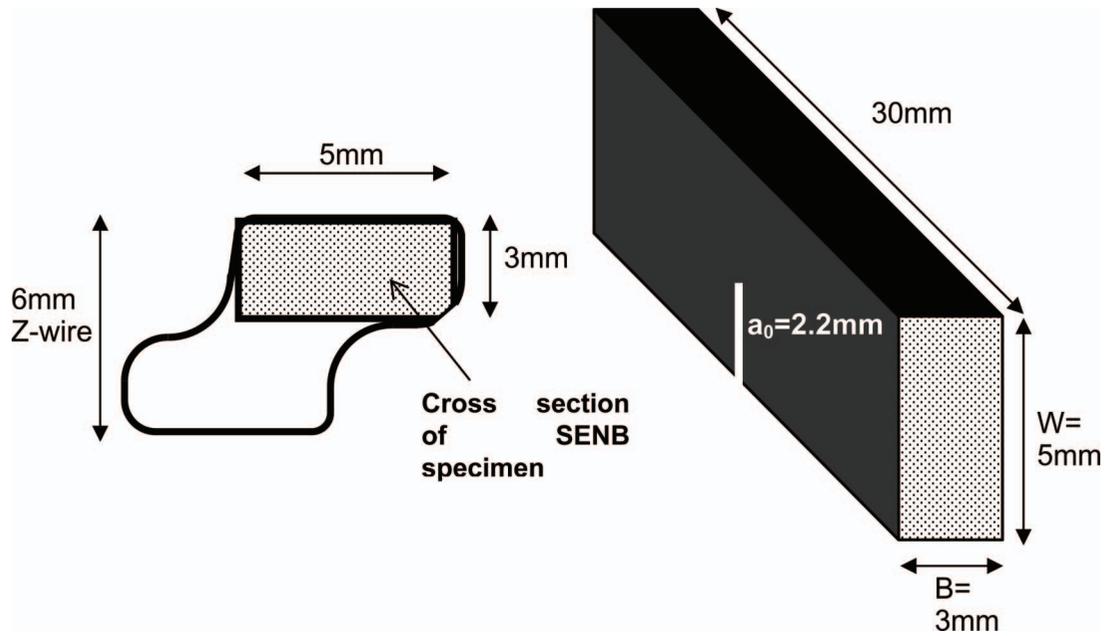
Figure 11. Preparation of SENB specimen from Z-wire.

Eight single edge notched bend (SENB) specimens were prepared from 6-mm Z-wire (type Z-60111) as illustrated in figure 11. The wires were spares from a previous investigation on the cables of the Lysefjord Bridge (Leinum 2001). The fatigue pre-cracking and fracture mechanics testing were performed according to the British Standard BS7448 (BSI 1991), at room temperature. The test set-up and an example of a fracture surface are shown in figure 12.

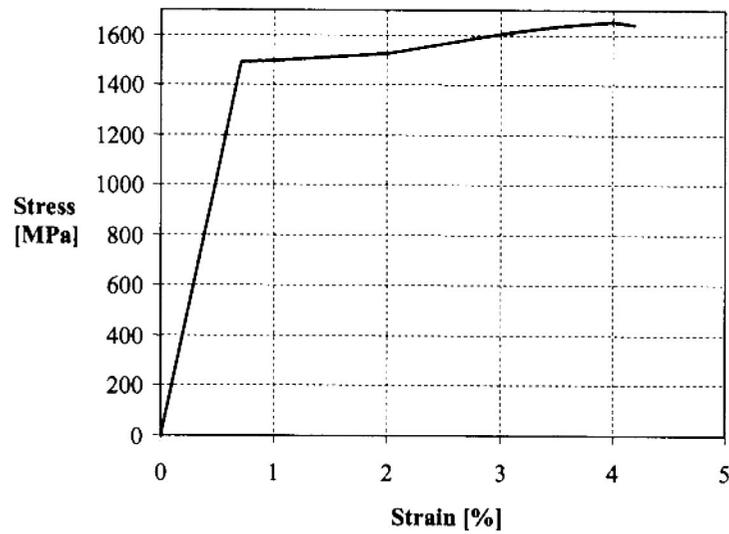
Figure 13. Adopted stress–strain curve to fit results from the production tests of 6-mm Z-wire.

As no stress–strain curve from the 6-mm Z-wire was present, a typical curve for similar material was adopted. The strength level and ductility of the adopted curve was adjusted to fit the reported yield strengths, tensile strengths and ultimate elongations of the production tests of the cables of the Lysefjord Bridge. The results are presented in table 2 and the stress–strain curve is presented in figure 13.

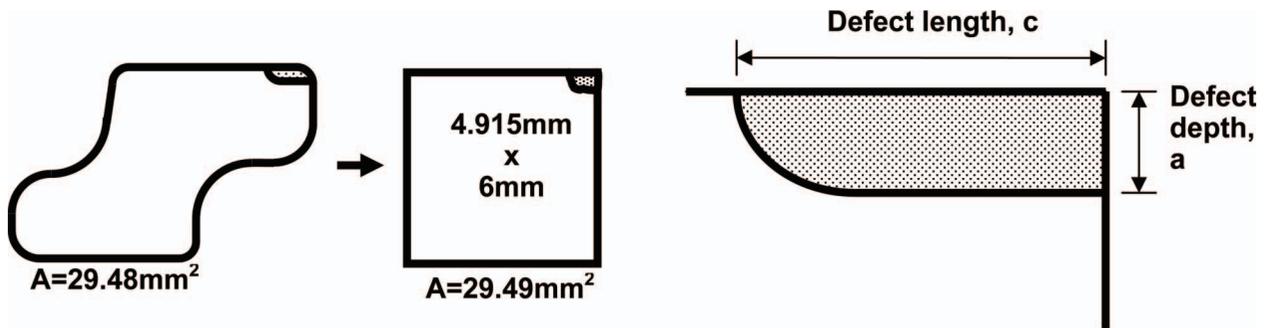
Figure 14. Illustration of the geometrical simplification of the Z-wire and the position and geometry of the typical corner defect.

The software tool Crackwise ver. 3.15 was used for the calculations. The software is based on BS7910, and a level 2B assessment was performed. A geometrical simplification of the Z-wire was required (see figure 14). The critical size for surface irregularities for the given loading condition is presented in figure 15.

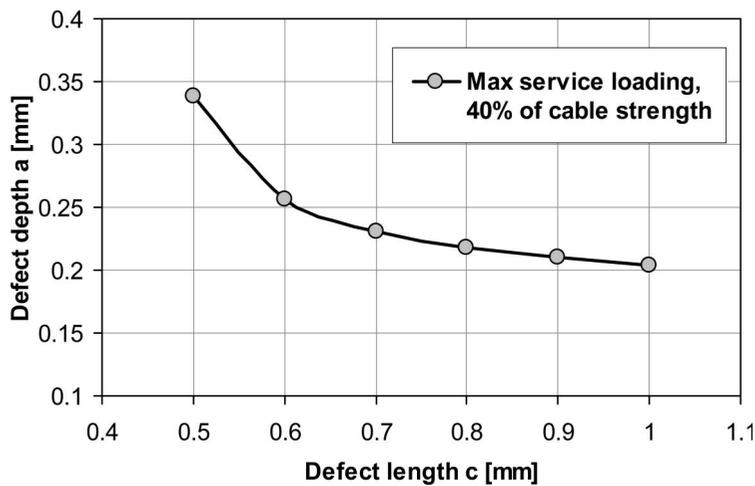
Figure 15. Critical defect sizes for 6-mm Z-wire at the given loading condition.

long-term environmental effect is evident. The environmental effect is most likely caused by hydrogen embrittlement, which could significantly reduce the fracture toughness. The environmental effect could most probably reduce the fracture toughness much more than the constraint of a shallow surface irregularity could increase it. This means that the critical defect sizes of figure 15 most probably are non-conservative, i.e. the actual critical defect sizes are smaller.

It is likely that the stress distribution between wires is not homogeneous. For wires with higher applied stress, i.e. >40% of the minimum required tensile strength of the cable, the critical size of surface irregularities is reduced compared to figure 15.

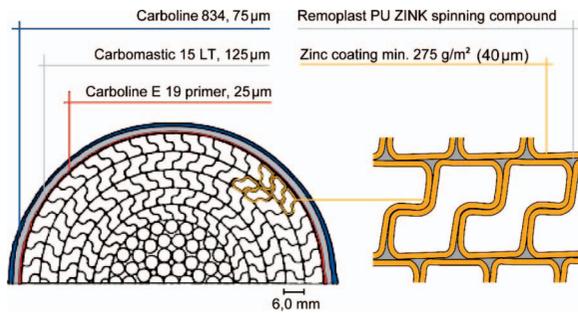
Figure 16. Corrosion protection for individual steel wires and the complete cable.

To extend the lifetime of a galvanized steel component, a layer of organic coating can be put on top of the zinc coating. The organic coating layer will prevent direct contact with the surrounding atmosphere (or water) and thereby reduce the corrosion rate of the zinc coating. Application of an organic coating layer on the individual wires is not a practical solution. However, for the final cable a three-layer epoxy coating from Carboline was applied. Figure 16 illustrates the final corrosion protection system that was used for the cables.

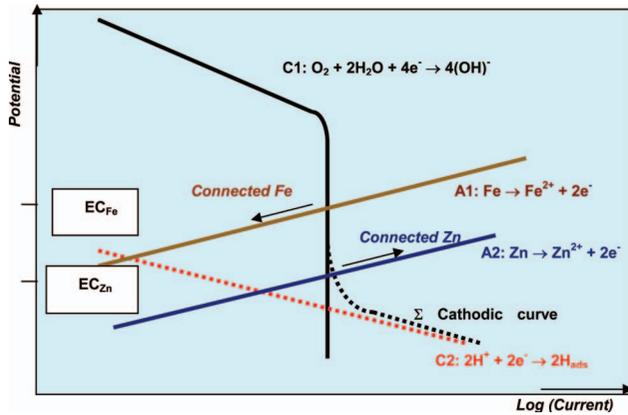
Figure 17. Schematic overvoltage curves for carbon steel (Fe) and zinc (Zn) showing connected and not-connected conditions.

Carbon steel and zinc will corrode when exposed to a humid environment. However, due to the development of a protective zinc carbonate layer the corrosion rate of zinc (*self corrosion*) is relatively low. When electrically connected and submerged in the same electrolyte, a galvanic cell will be established between the two alloys. In this cell, zinc is the less noble alloy and will protect carbon steel against corrosion. Figure 17 shows a schematic of the overvoltage curves for anodic and cathodic reactions:

Figure 17 also shows the cathodic curves for equations (3)–(5). As can be seen from the curves, the development of hydrogen increases with more negative potentials. This means that corrosion of zinc will promote the development of hydrogen atoms.

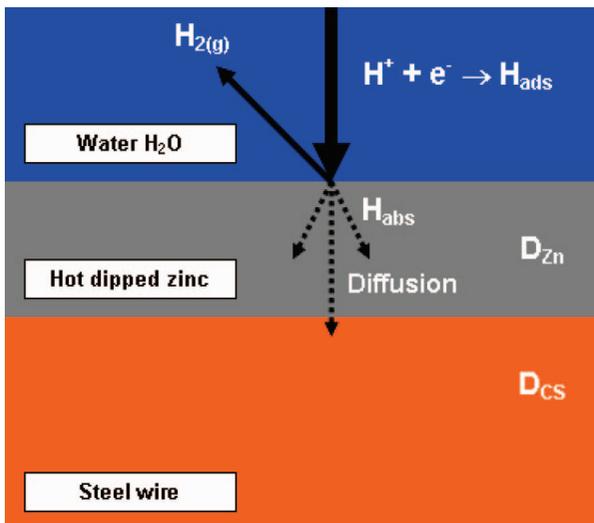
Figure 18. Schematic of hydrogen generation through the corrosion reaction of zinc and diffusion through the zinc coating into the steel wire (D_{Zn} and D_{CS} are diffusion coefficients for zinc and carbon steel, respectively).

where D_{H} is the diffusion coefficient and C_{H} the concentration of hydrogen in the metal for one-dimensional flow. See figure 18 for a schematic view of equations (5)–(7) and diffusion assuming corrosion on the zinc coating covered by a water film.

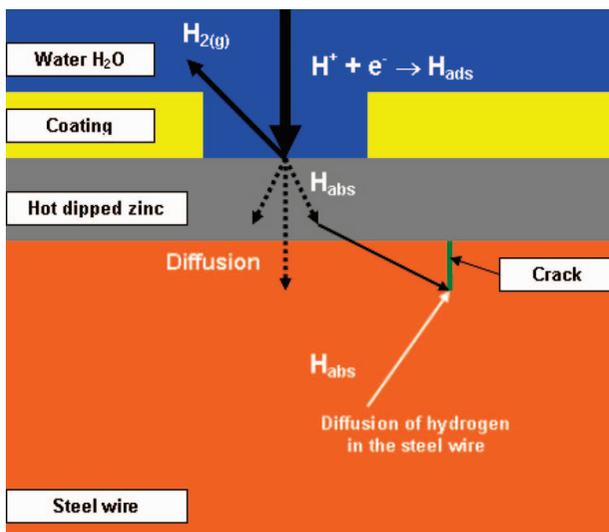
Figure 19. Schematic of a steel wire with damaged organic coating covered with a water film where zinc corrosion generates hydrogen that is partly absorbed and diffused into the metal.

7.2.2 Hydrogen from corrosion of zinc on a surface without organic coating. Zinc exposed to a marine atmosphere will corrode with a corrosion rate less than $10 \mu\text{m}/\text{year}$ (Olden *et al.* in press). Due to the corrosion potential of zinc in the range $\approx -1000 \text{ mV Ag/AgCl}$, the cathodic reaction will be a combination of equations (3) and (4). The adsorbed hydrogen H_{ads} can then either be absorbed in the zinc coating as diffusible hydrogen or recombine and produce hydrogen gas $H_{2(g)}$ according to equation (7). The amount of absorbed hydrogen depends mainly on the temperature, availability of oxygen, pH of the water and the surface condition. Figure 19 shows schematically how absorbed hydrogen diffuses through a local crack in the steel wire.

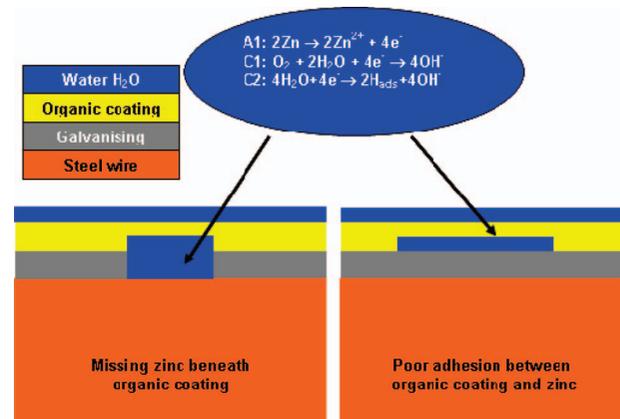
Figure 20. Schematic presentations of local water volumes beneath an organic film with poor adhesion to the zinc coating.

water) and thereby reduce the corrosion rate of the zinc layer. However, both water and oxygen will diffuse into/through the organic coating. As long as the coating is bonded to the zinc layer, no accumulation of water will occur and corrosion of the zinc layer is prevented. However, if the bonding is lost water will accumulate in the volume between the organic and the zinc coating and corrosion of zinc will occur. The corrosion rate depends on the chemistry of the water and the diffusion rate of oxygen. In the literature, permeability values have been reported in the range 10–30 g/m² per day for water through a 300- μ m thick epoxy coating (Funcke *et al.* 1978). Figure 20 shows a schematic of this situation with corresponding anodic and cathodic reactions, assuming both reactions occurring in the water volume beneath the intact organic film.

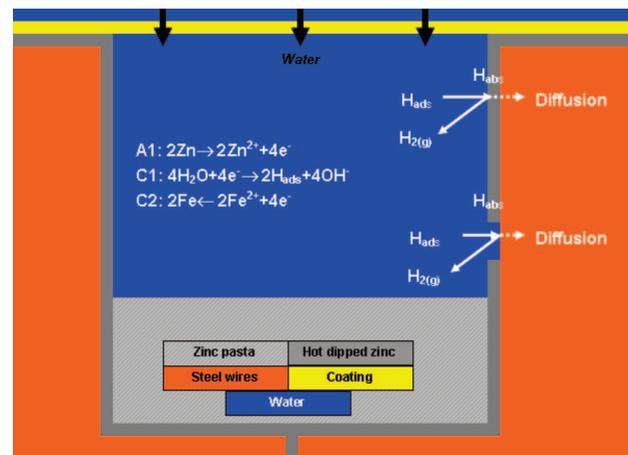
Figure 21. Schematic of a volume, where parts of the volume to be filled with 'spinning compound' is filled with water diffused through the organic coating. In this case, damage in the zinc-coated area is included.

Figure 21 shows a schematic of a volume where the spinning compound is lacking and the volume is filled with

water that is diffused through the organic coating. As long as water penetrates the organic coating corrosion will occur on the zinc coating according to equation (2) with corresponding cathodic reactions according to equations (3)–(6). As can be seen from equations (3)–(4), water will be consumed as a result of the corrosion reaction. The corrosion rate will probably depend on the diffusion rate of water through the organic coating film.
